NASA Technical Memorandum 78796

THE EFFECT OF IMPACT DAMAGE AND CIRCULAR
HOLES ON THE COMPRESSIVE STRENGTH OF A
GRAPHITE-EPOXY LAMINATE

James H. Starnes, Jr., Marvin D. Rhodes and
Jerry G. Williams

October 1978

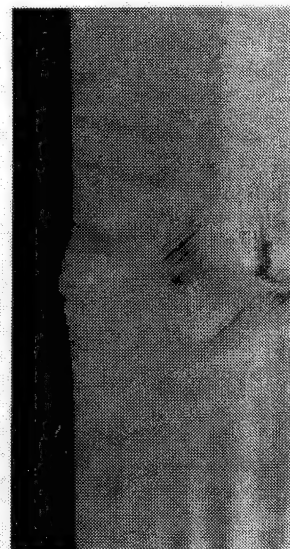
(a) 48 percent of residual strength.

(b) 61 percent of residual strength.

(c) 98 percent of residual strength.

(d) Failed specimen.

Figure 9. - Moire-fringe patterns during residual-strength test of an impact damaged specimen.

Photographs of successive moire-fringe patterns from the residual strength test of specimen N7 are shown in figure 9. Specimen N7 was impacted at 91 m/s with no applied axial load. The photograph in figure 9a shows the moire-fringe pattern of the damaged region at 48 percent of the specimen residual strength. The small light colored circular region in the center of the specimen is the impact site which is beginning to deform out-of-plane. This deformation is the first observable response of the damaged region to the applied axial load. Subsequent moire-fringe patterns (figs. 9b and 9c) represent local buckling of the impact-damaged region that grows laterally as the applied load is increased. The photograph in figure 9d shows the failed specimen with the damage propagated laterally across the specimen in the same manner as the example shown in figure 7. Examination of the failed specimen removed from the test fixture confirmed that the damage propagated laterally and was confined axially to the region indicated in figure 9d.
